U.S. ENVIRONMENTAL PROTECTION AGENCY, REGION II

MEMORANDUM

TO: Mike Negrelli, RPM
FROM: Robert M. Alvey, P.G.
DATE: April 12, 2016
SUBJECT: Five Year Review Site Inspection
Hooker Chemical/ Ruco Polymers Superfund Site
Hicksville, NY

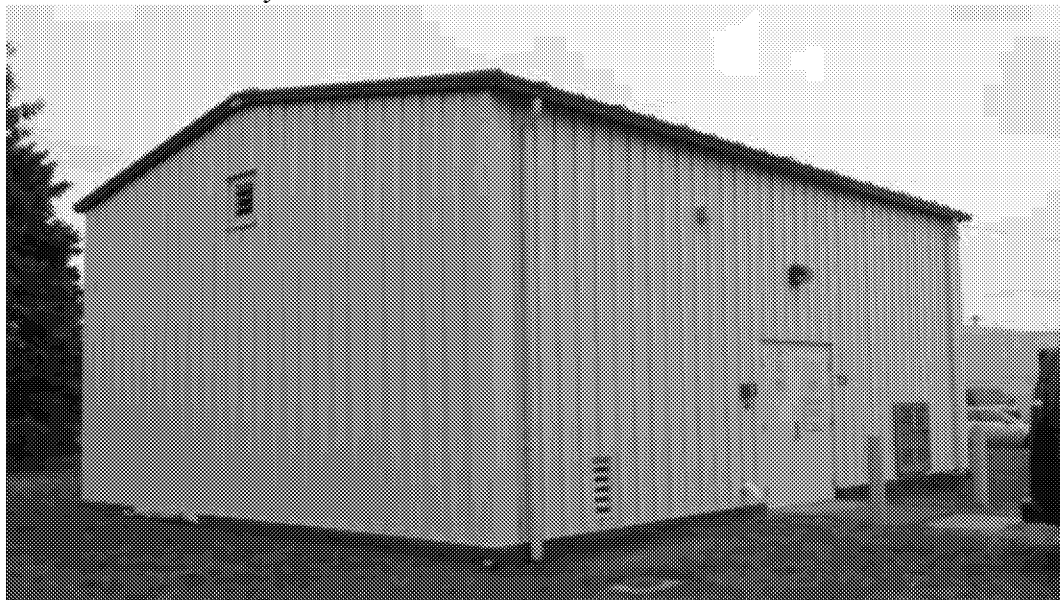
Hooker Chemical/Ruco Polymers Biosparging Treatment Building, Hazel Street.

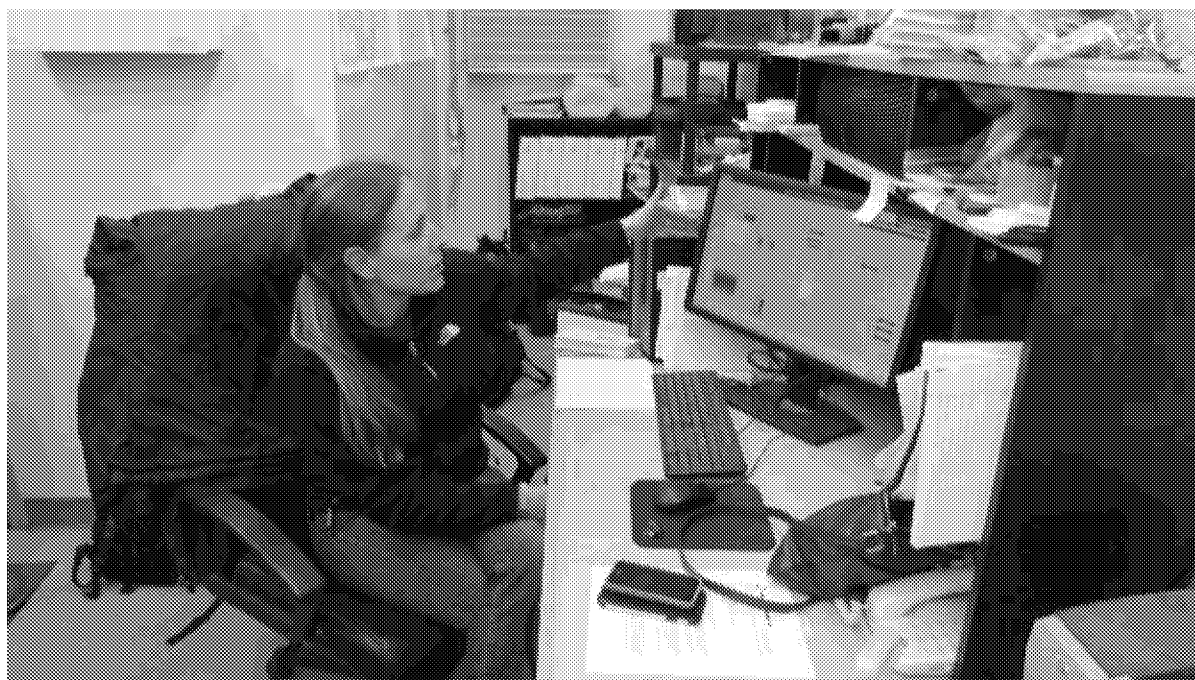
Valerie Whalen, C A Rich Consultants, demonstrating system control board operations at the Hooker-Ruco treatment building.

current operations. The plant appeared to be in good operating condition, clean, and quiet while the compressors were not in operating mode.

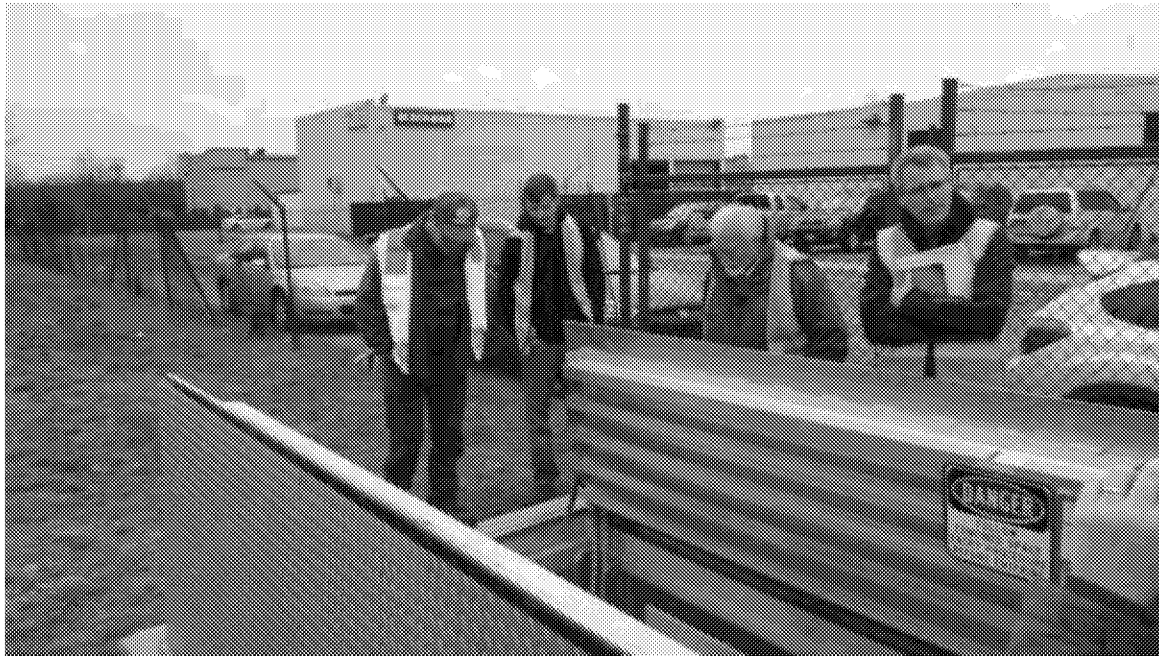
Viewing injection vault with Steve Scharf- NYSDEC, Mike Negrelli- EPA, and Klaus Schmidtke and Roger Smith- Glen Springs Holdings.

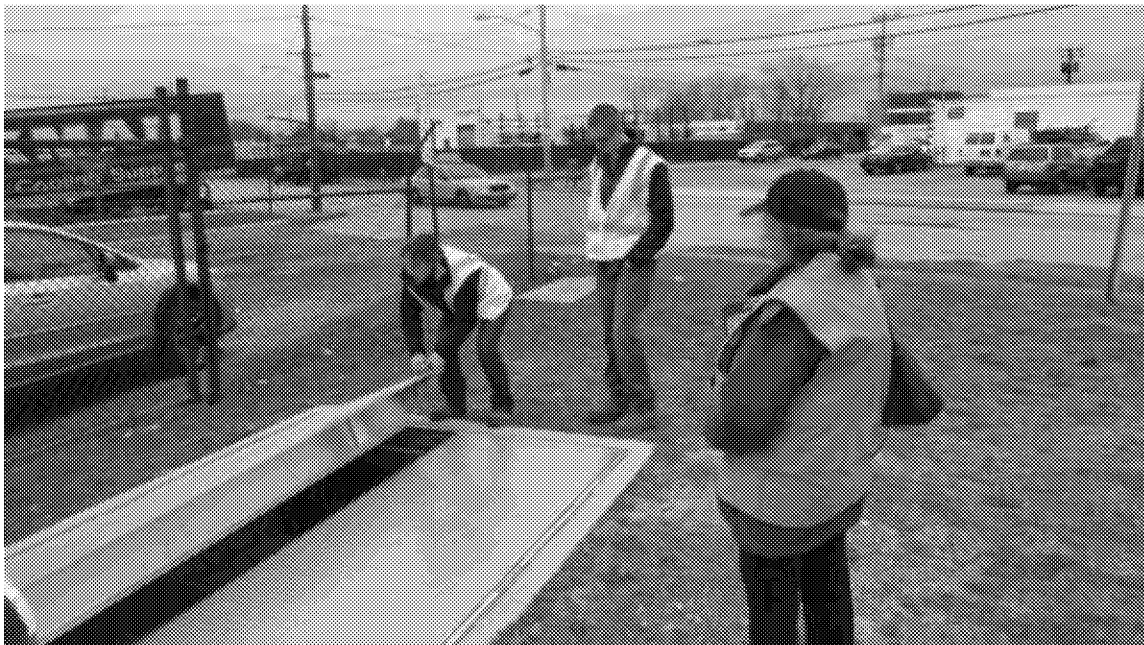
Injection vault being opened by Victoria Whalen and William Fischett, C A Rich Consultants. Carol Stein- EPA observes.

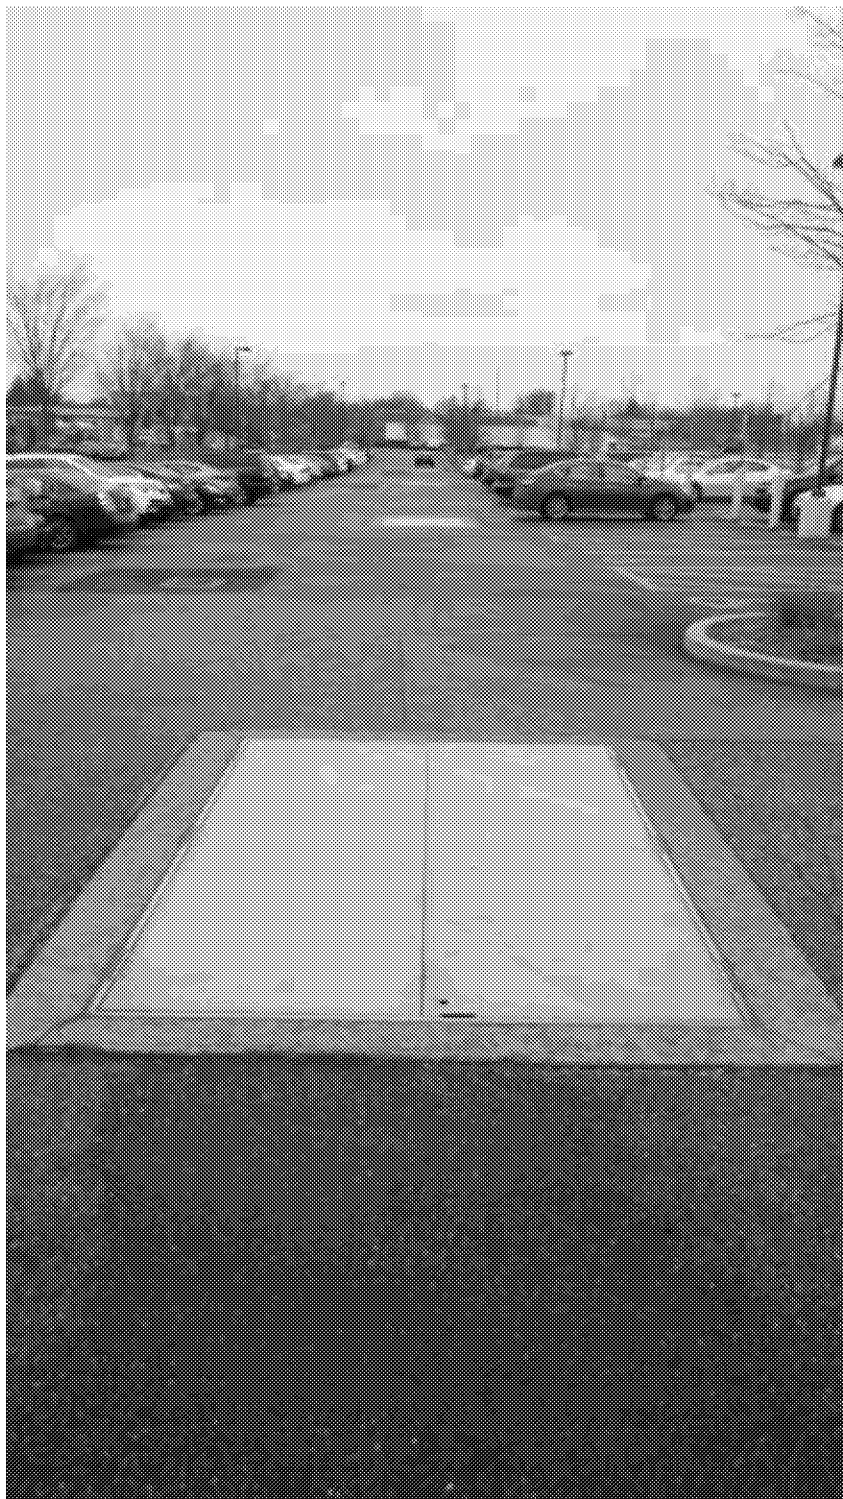
Photo of injection vaults along transect in Sleepy's bedding store parking lot.

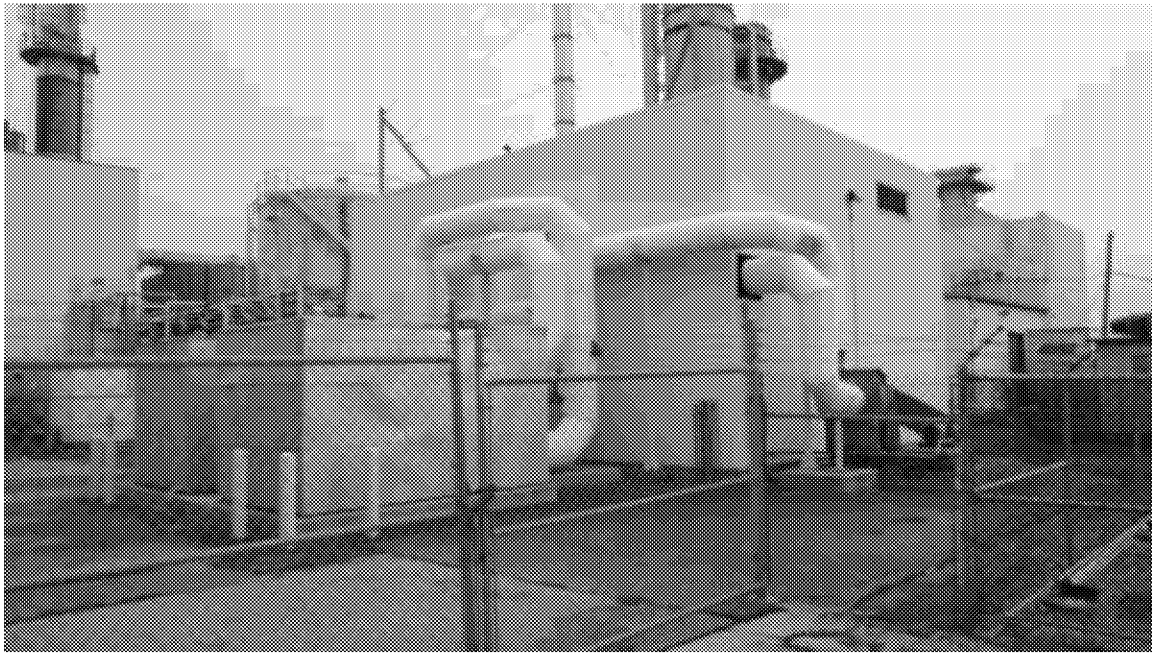
Hooker Ruco Vinyl Chloride Removal System operating in support of Northrop Grumman-Bethpage Groundwater Treatment System.

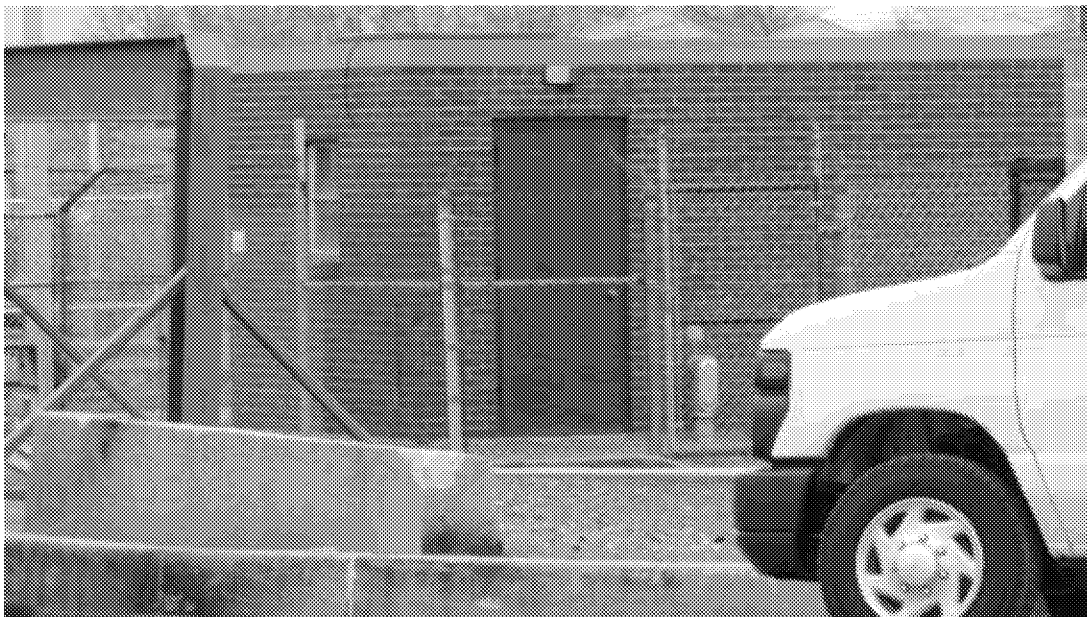
Access was provided to observe the location of the pretreatment system installed by Hooker Ruco on the Northrop-Grumman property in the vicinity of former Grumman Production Well 3 and current Extraction Well 3R. When vinyl chloride from the Hooker Ruco plume was detected at Northrop Grumman Extraction Well 3, a pretreatment system was installed. The Northrop Grumman Extraction Well 3, utilized to capture a significant amount of groundwater contamination from this area, failed and was replaced by Extraction Well 3R by Northrop Grumman in 2015.

Brick building housing former Northrop-Grumman Production Well 3.

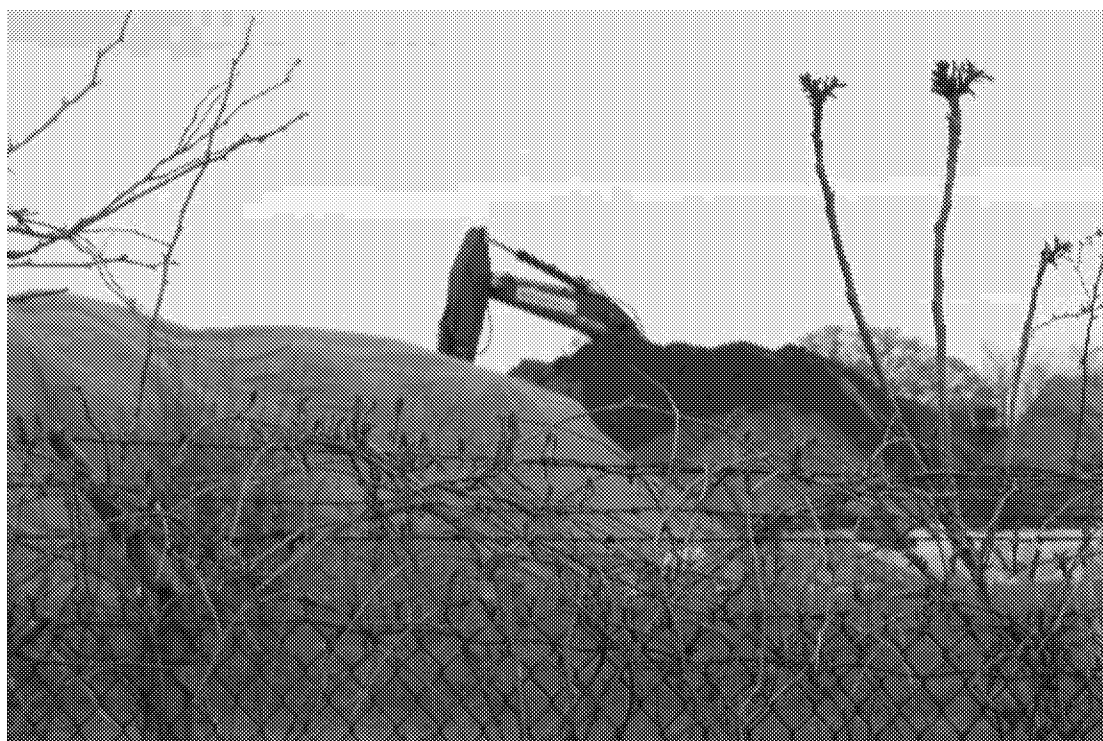
Bayer OU-4 Soil excavation 2015 (Former Hooker Ruco site)

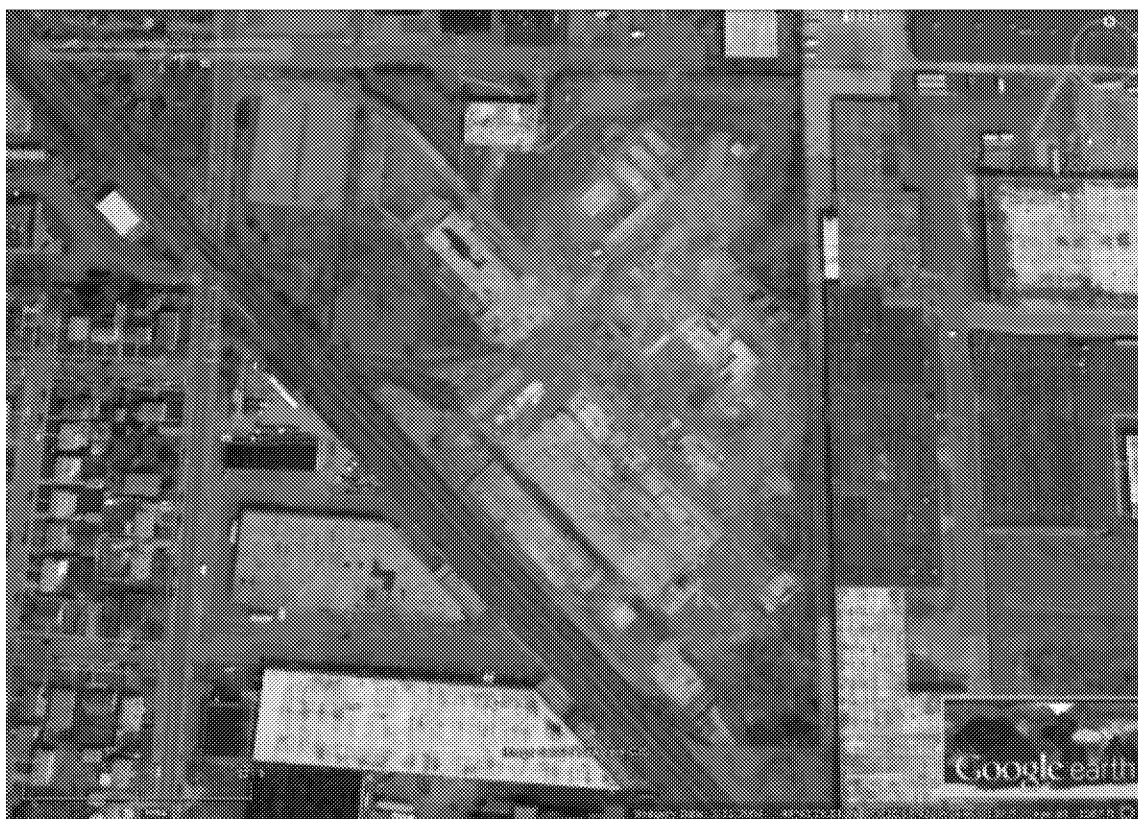
Former Hooker Ruco Site (Bayer OU-4) Soil Excavation overview. May 23, 2015 (above) and Mar 31, 2004 (below) photo credits: Google Earth
